TITLE: VS-10 Causes Occasional Servo Instability

FIELD ENGINEERING BULLETIN

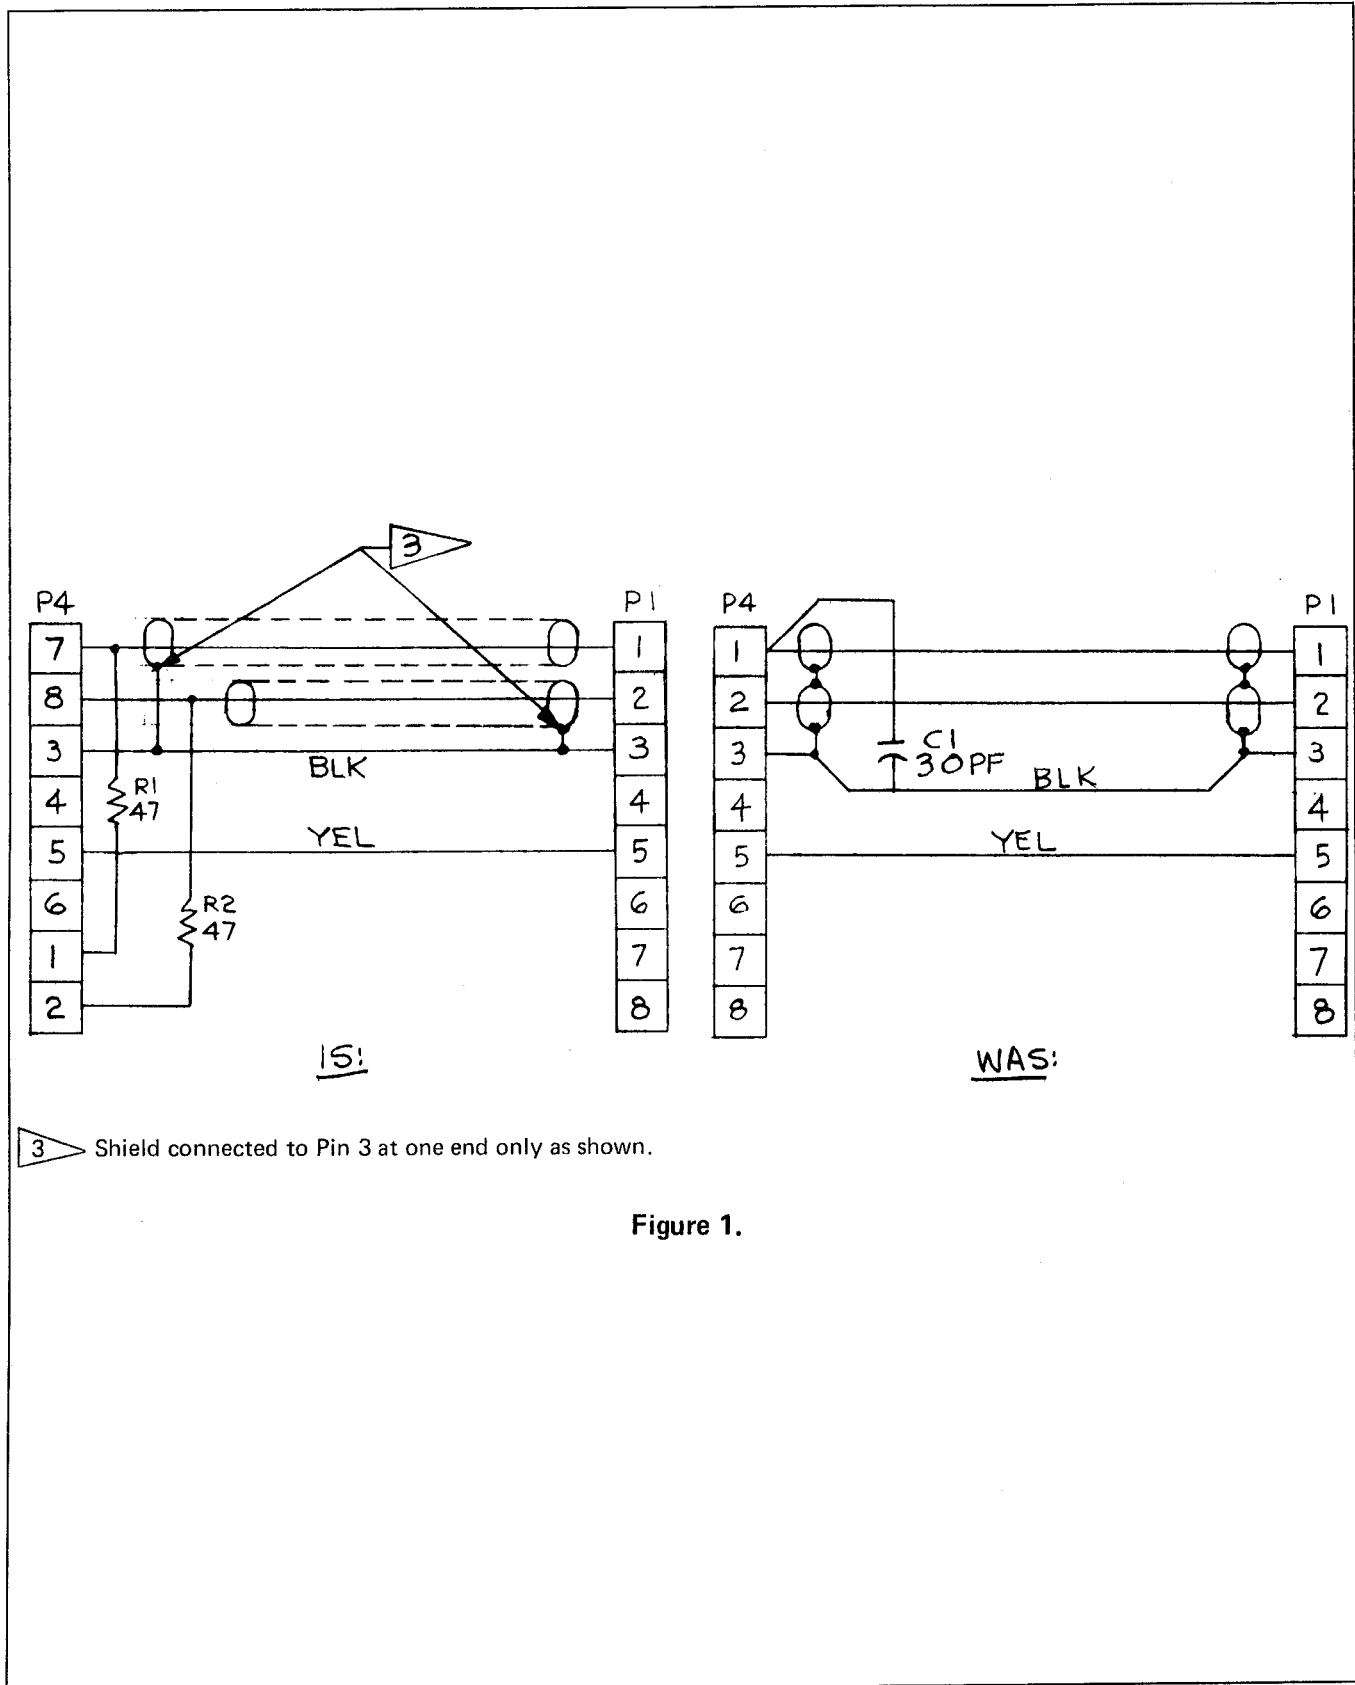
Early VS-10 interconnect cables caused capstan servo instability occasionally. This modification completely eliminates the problem.

The existing interconnect cable must be rewired using existing wiring in the harness. A capacitor is removed from the connector shell and two resistors are substituted.

- 1) Remove and discard capacitor C1 (30PF) from PINS 1 and 3 of P4.
- 2) Remove wire on P4-1 and move to P4-7 as shown in fig. 1.
- 3) Remove wire on P4-2 and move to P4-8 as shown in fig. 1.
- 4) Add 2 resistors R1 and R2 (47 OHM, 1/4W, 5%) P/N 041-425 to P-4 as shown in fig. 1.
- 5) The harness shielding will attach at one end only.
